Exposed concrete The challenges of board marking

Command of the Oceans

The Historic Dockyard Chatham

Brendan Higgins of Baynes and Mitchell Architects looks at the use of exposed concrete for a new entrance building within Chatham's historic dockyard.

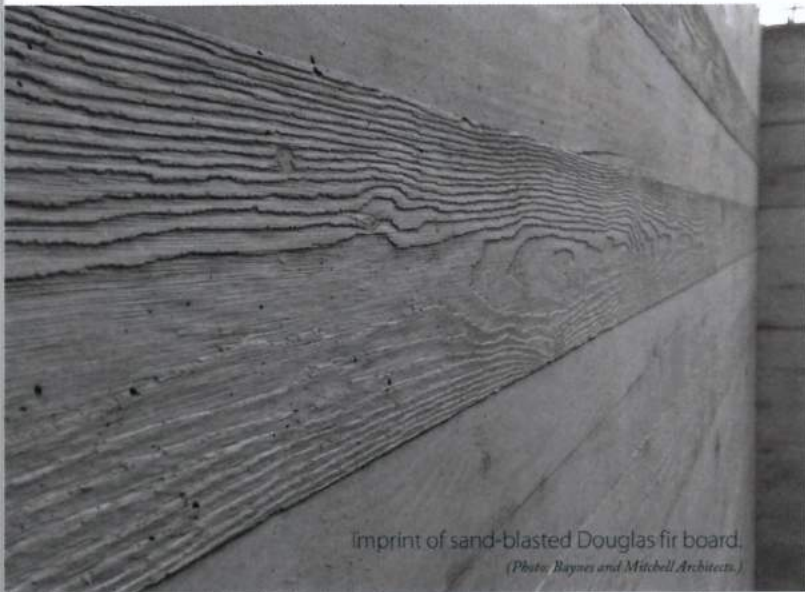
Imprint of sand-blasted Douglas fir board.
(Photo: Baynes and Mitchell Architects.)

A horizontal board-marked finish to the concrete face was chosen, with alternating smooth planed and sand-blasted Douglas fir boards used as formwork. These boards were arranged randomly on several standardised casting panels, which were reused throughout the build. The timber surface was coated with a sealant, which enabled high reuse without significant board degradation.

The concrete specification advisor, David Bennett, suggested that in order to enhance the visual appearance of the timber grain on the concrete surface, a concrete with 30% fly ash cement replacement be used. This gives the concrete a mid-grey colour, allowing the grain of the timber to be read in the daylight spaces of the building, where a lighter concrete would have been too reflective and perhaps resulted in a loss of definition. The

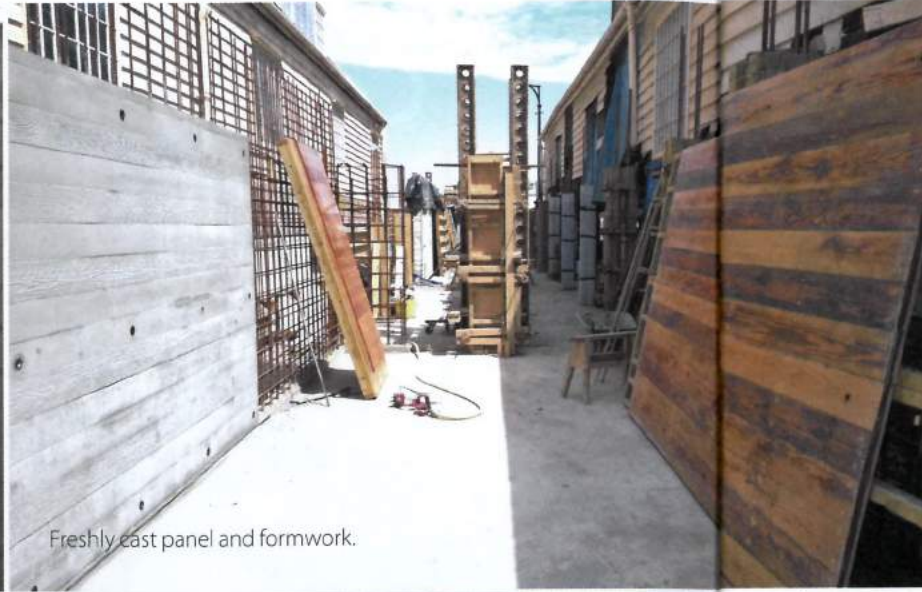
Freshly cast panel and formwork.

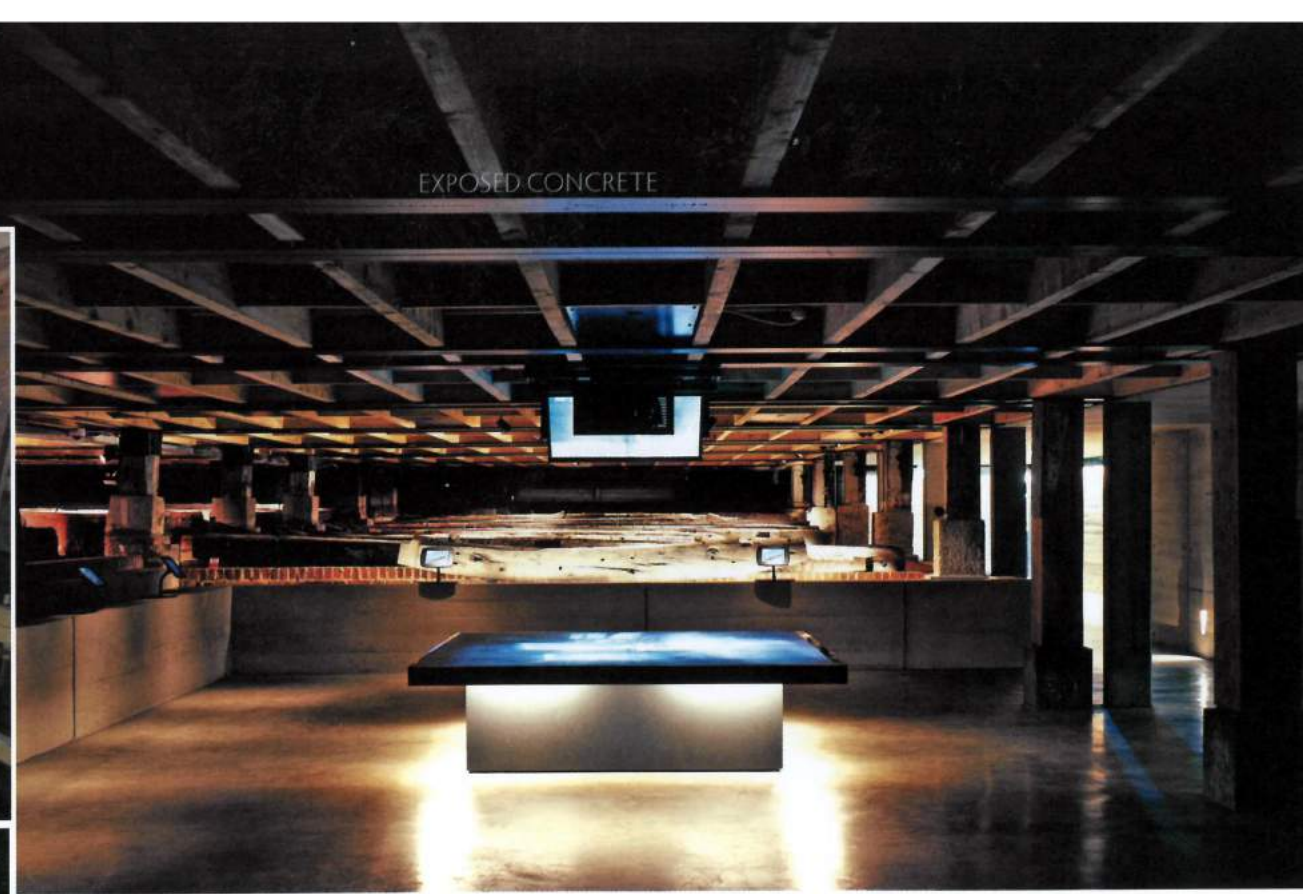
Undercroft, with the remains of the unknown ship. *(Photo: Hélène Binet.)*

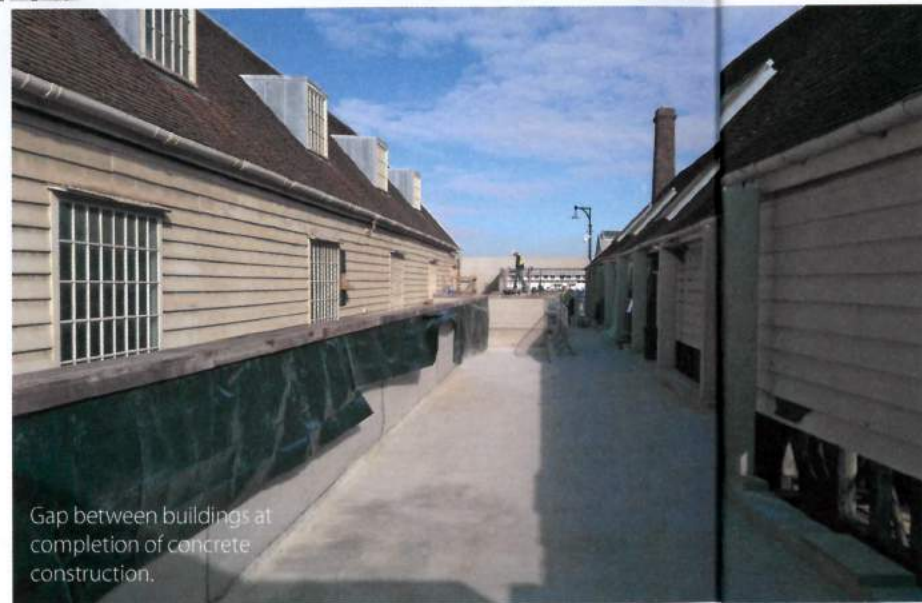
Gap between buildings at completion of concrete construction.

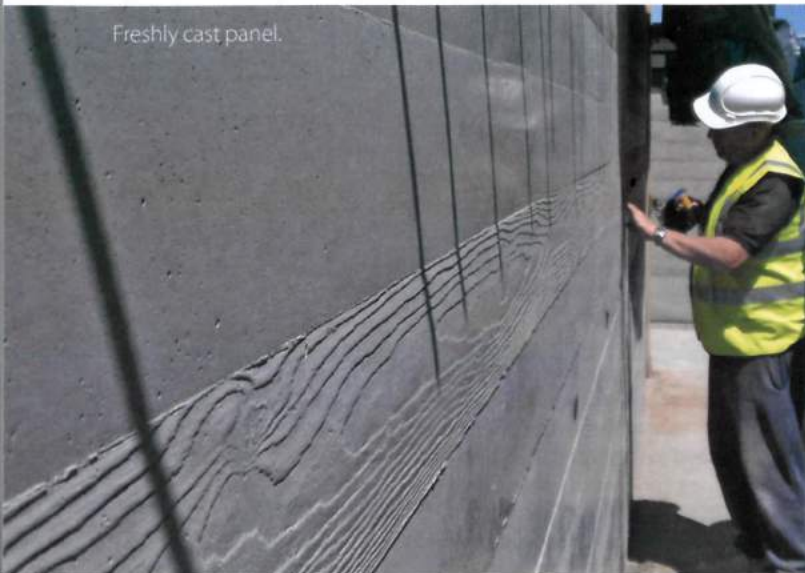
Freshly cast panel.

Thankfully, the lessons learned during the construction of the sample panel proved to be sufficient and the first panels of the build achieved the quality of finish that was targeted. Subsequently, these panels formed the quality control panels, against which the rest of the build was judged.
